National Park Service
U.S. Department of the Interior

Golden Gate National Recreation Area
California

Fort Point United States Coast Guard Station Historic District Summary Cultural Landscape Report

Golden Gate National Recreation Area
San Francisco, California
January 2008

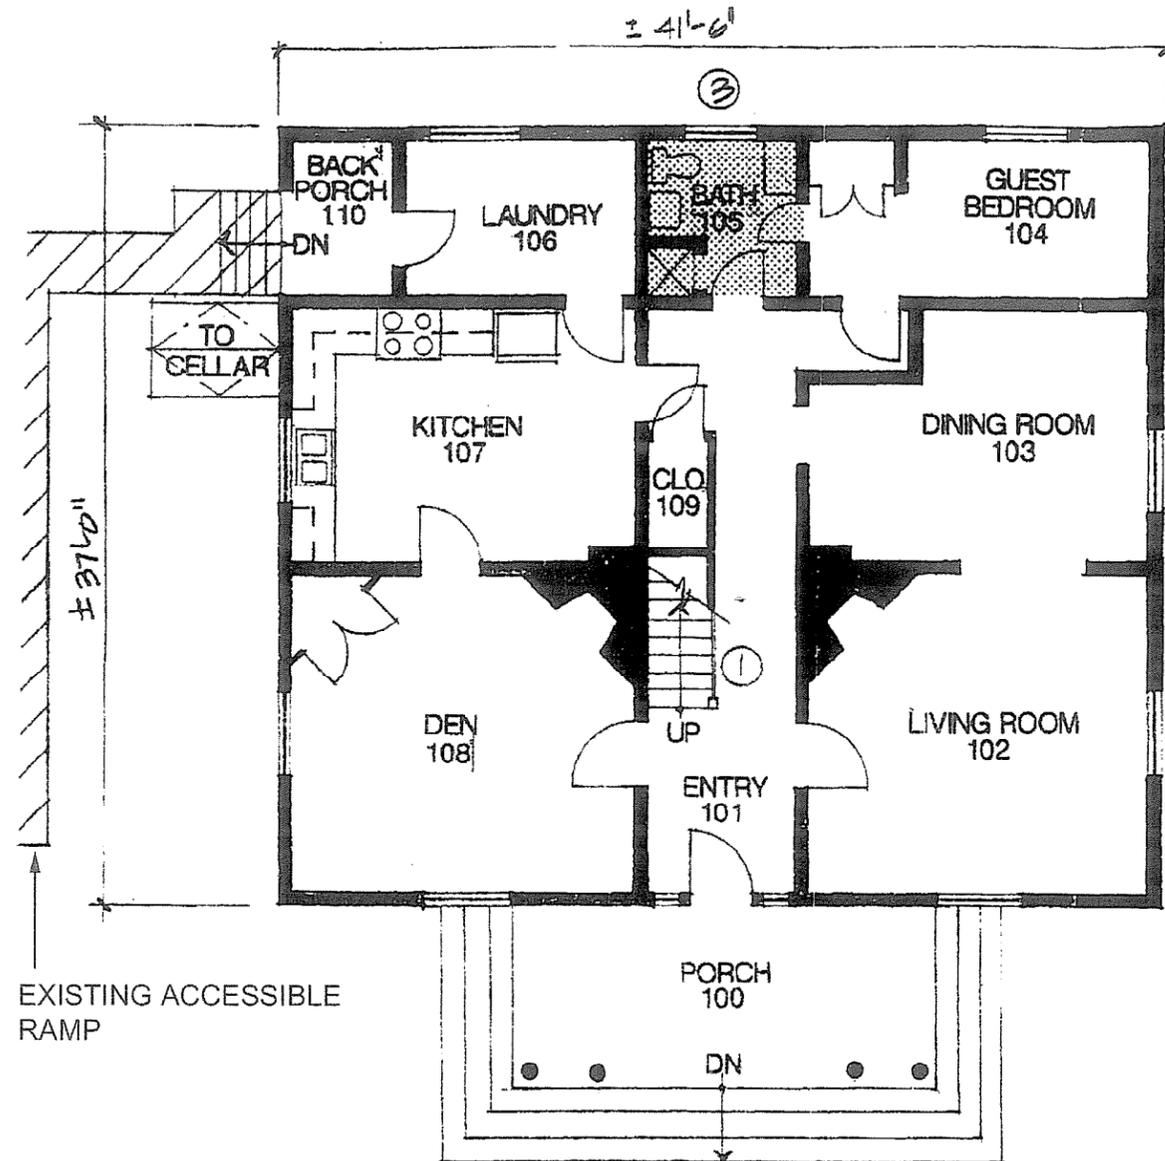
Figure 8: Building 1901, First Floor Layout, ICAP Report, dated 1993, from the GGNRA park files. This ICAP Report drawing documents repair needs at the time of the survey. In 1993, the report indicated there was no handicap access at the front porch and that it was inappropriate to provide building access from the laundry room. This access has remained unchanged.

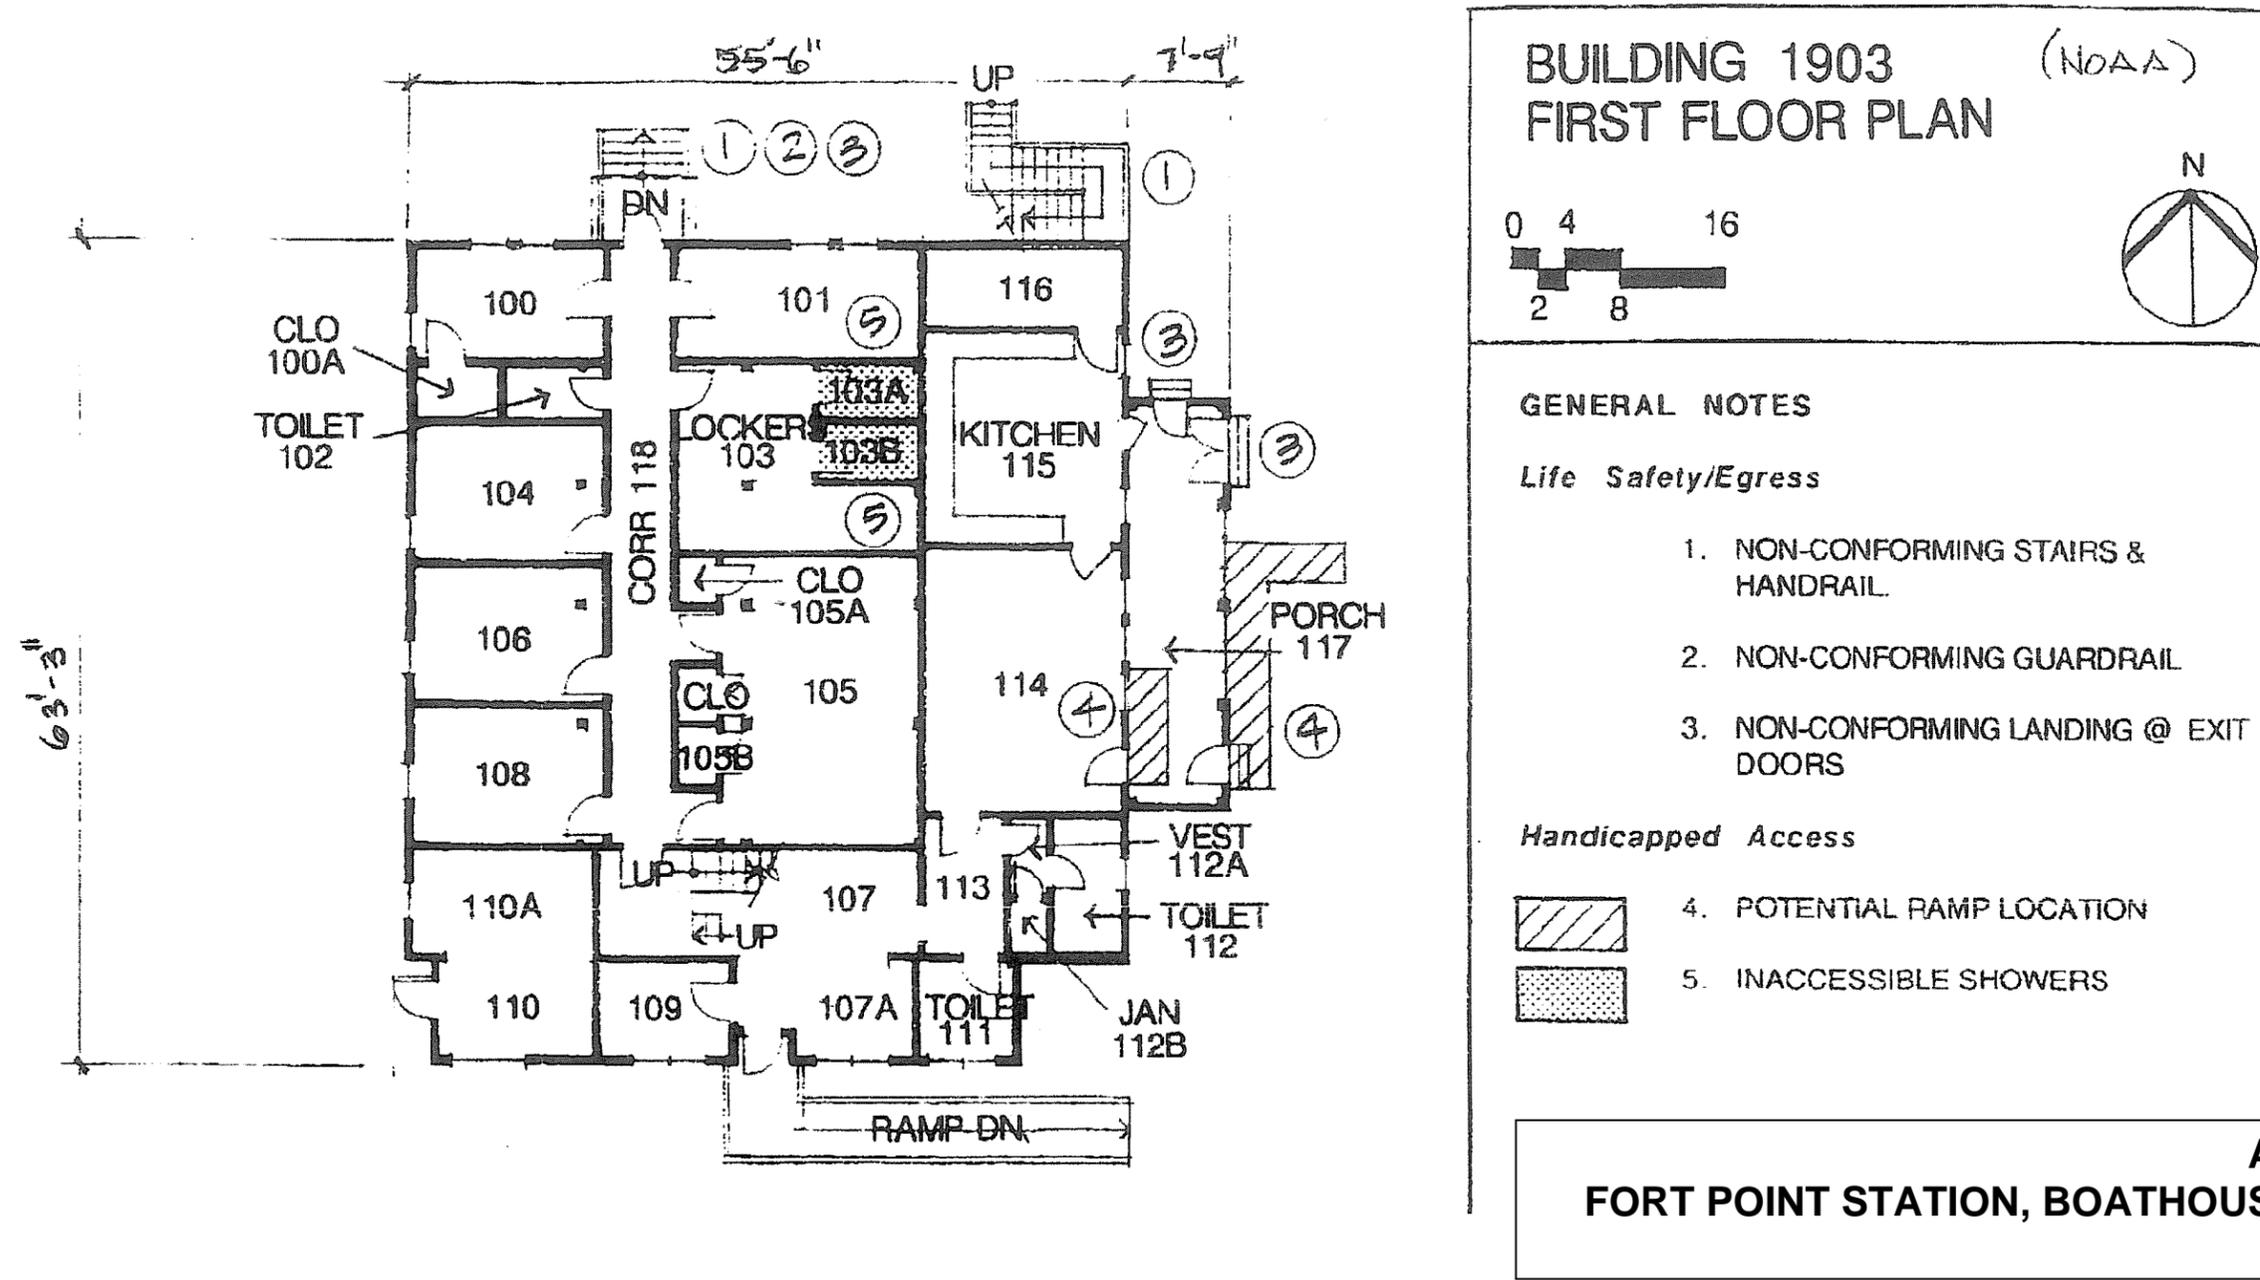
Figure 10: Access, Building 1903, First Floor Layout, ICAP Report, dated 1993, from the GGNRA park files. This ICAP Report documents current repair needs at the time of the survey. In 1993, the report indicated there was no handicap access provided at the Porch adjacent to room 117, and no ramp provided from room 117 to rooms 114 and 115. The ICAP report drawing illustrates one way to access the porch, which functions as a small museum, via an accessible ramp.

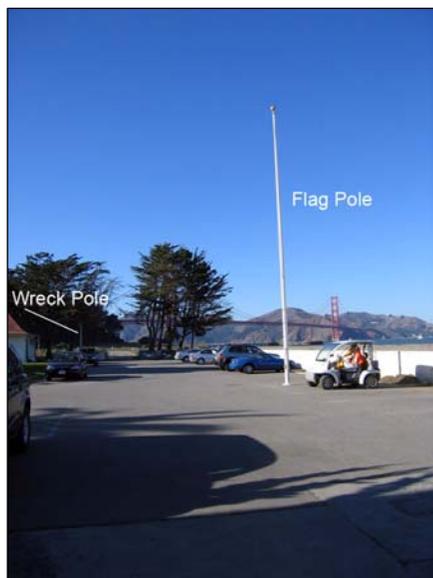
This fifty-foot high flag pole, painted white with a golden ornamental fixture at the top, is adjacent to the seawall and beach. It is sited in the former drill ground (current parking lot) and is on axis with the main entry into the U.S.C.G. complex. It is in fair condition.

[10]: Image of flag pole and wreck pole—both are located on the northeast side of the district. The Monterey Cypress “windbreak is visible between the Flag Pole and Wreck Pole. (PWR Staff—2005).

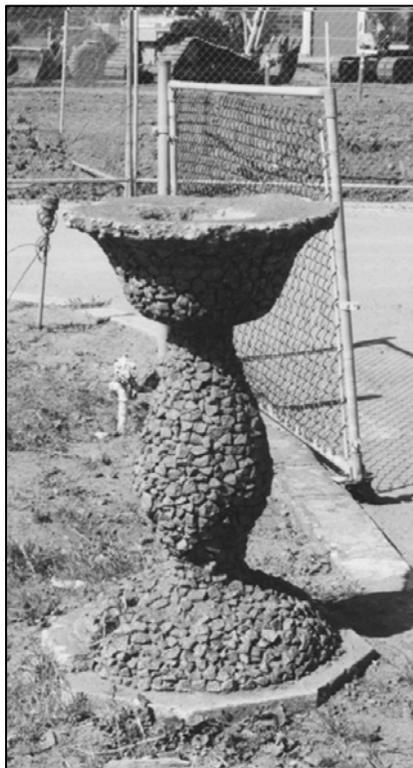
[11] *The remaining fountain currently located at the eastern entrance to the station. It was moved to this location during the Crissy Field Redevelopment project (NPS Staff—1999).*

- Careful excavation of the circular concrete pad areas within the lawns to the east and west of the Boathouse (building 1903) may reveal more of the fountain bases and related plumbing. More thorough research regarding the nature of these fountains would be required prior to replacing them. Otherwise, the presence of the fountains in the locations identified in the 1938 and 1958 Period Site Plans is well documented. If additional photographs showing the fountains cannot be discovered, consider replacing the fountains in kind. The original fountain/pedestal should be restored. Repair the remaining fountain, if possible, and prepare a cast from which two new replica fountains can be created.
- Restore original fountain between Residence and Boathouse on circular slab.

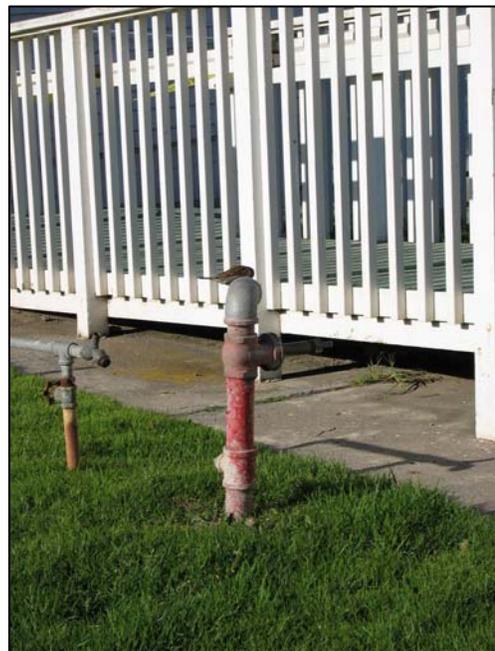
[12] Historic fire hydrant and hose bib located on the lawn at the southwest side of the site (PWR Staff—2005).

- There are several hose bibs within the lawn areas that are referenced in the 1938 Period Site Plan. Abandoning these hose bibs in favor of quick couplers that work from the new irrigation mainline makes good sense. The reason the hose bibs were there was for purposes of watering the lawns and hedges by dragging hoses with sprinklers attached around the site. The treatment recommendation is to leave the old piping in place and cut and cap the supply line. This would be in keeping with the historic scene, as the remaining hose bibs would be visible in the lawn areas. This would require careful mowing and trimming around the hose bibs.
- Add an automated irrigation system to the site. This would enable more efficient maintenance practice. Over the years, utility upgrades have routinely taken place, and adding an automated irrigation system is one more phase in the process.

- According to a representative from the Presidio Fire Department, as of July 2001, there is only one working fire hydrant that serves all buildings in the Fort Point Station complex. This fire hydrant, located on the southwest side of building 1903, has recently been repaired and is considered adequate for fire protection. A best case scenario would include installing one modern hydrant at this site.

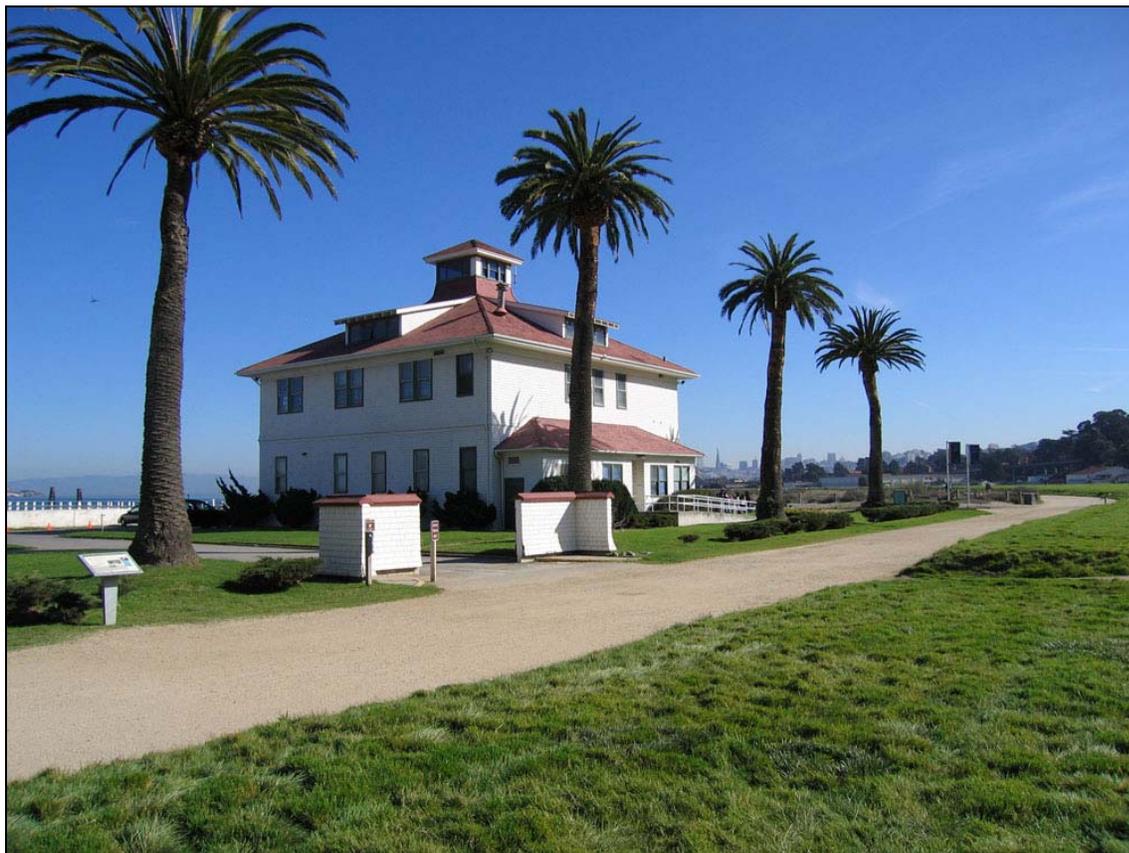
Two small scale features were constructed in 1983 by the Denver Service Center and do not contribute to the historic district: the entry gate at the central axis of the site off of Crissy Promenade, and a wall adjacent to the driveway to the old boathouse. Both of these features are constructed of white shingles with metal flashing at the top.

[13] Canary Island date palms and juniper hedge lining the southwest edge of the site. View to the east. The shingle clad gates are non contributing features that were added in 1983. The gates should be removed (PWR Staff—2005).
