Tomales Bay Eelgrass Habitat Evaluation, Site Monitoring and Restoration Plans

May 2018 Advisory Council Meeting

Site Monitoring in Areas Affected by Vessel Moorings

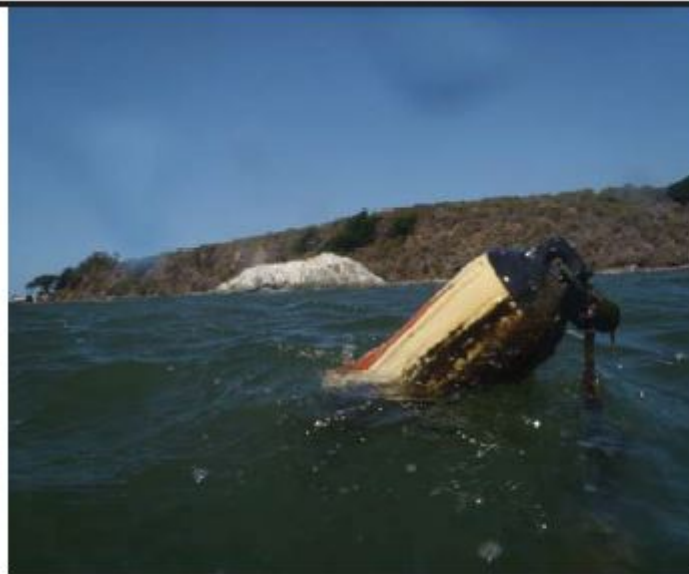
Mooring #: 100 (See Report Figure 2D)

2015 Eelgrass Status: Not in eelgrass however, some patchy eelgrass may have been impacted by ground chain based on excavation location.

CDFW Eelgrass Zone: Mooring outside but ground chain extends into eelgrass zone

Inspection Notes: Fender was connected to chain, which ran down to the bottom. There was approximately 30 meters of chain coiled up and zig-zagging back and forth. It ultimately ends up connected to a 55-gallon drum. Excavation to south of mooring is ground chain derived.

Recommendations: Shorten ground chain and relocate mooring to the southeast by 20 meters

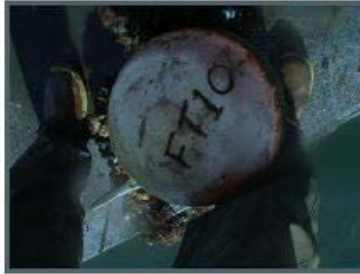
1.20 FT10 38.14185, 122.87637
Cut chain on mooring.

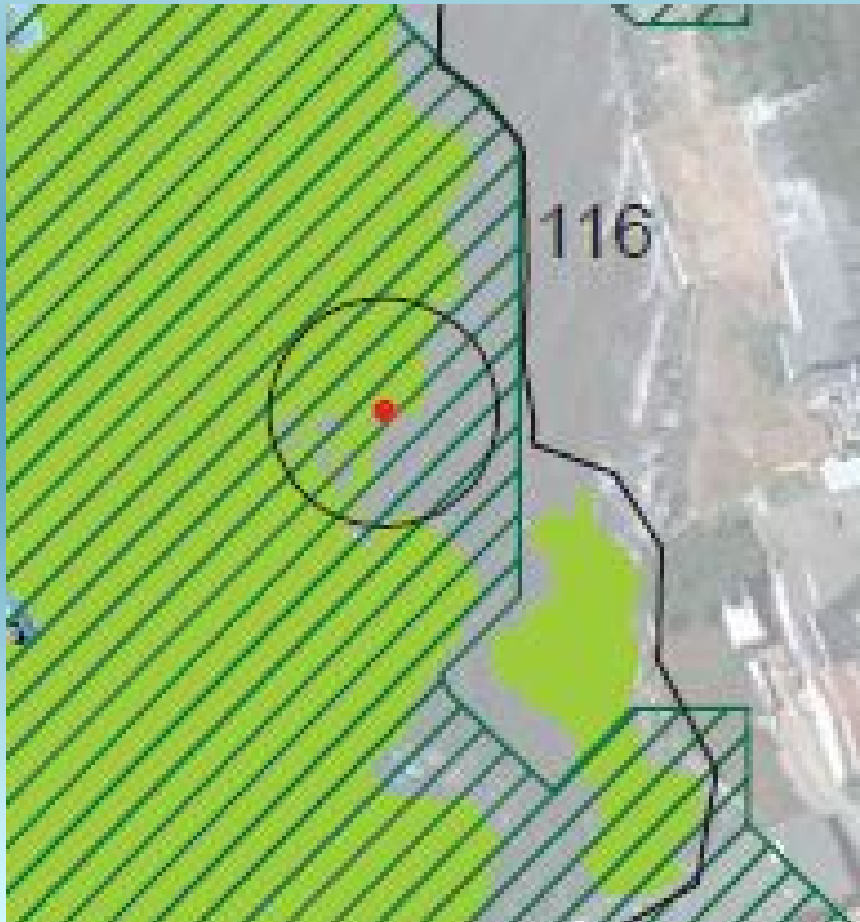
2015

Habitat Evaluation Results: Inn at Tomales Bay

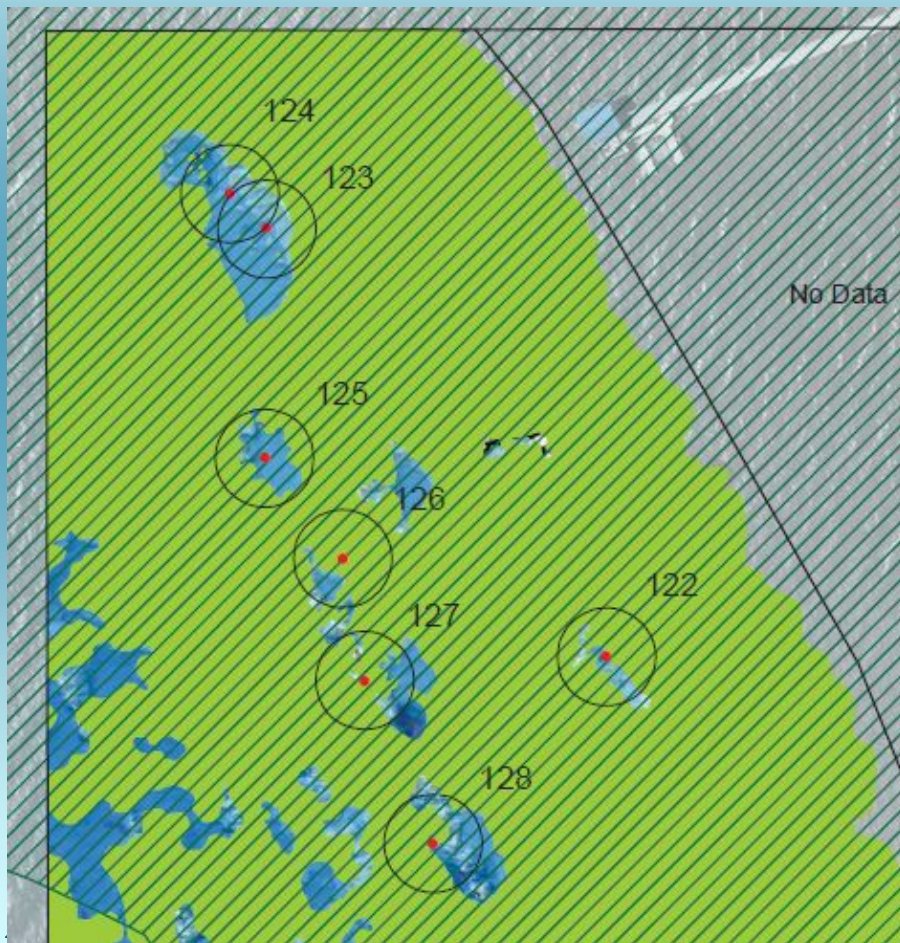
2015

Habitat Evaluation Results: Nick's Cove
