Bolinas Lagoon Watershed Study

Input Sediment Budget

Prepared For:
US Army Corps of Engineers
333 Market Street
San Francisco, CA 94105

Prepared By:
Tetra Tech, Inc.
180 Howard Street, Suite 250
San Francisco, CA 94105

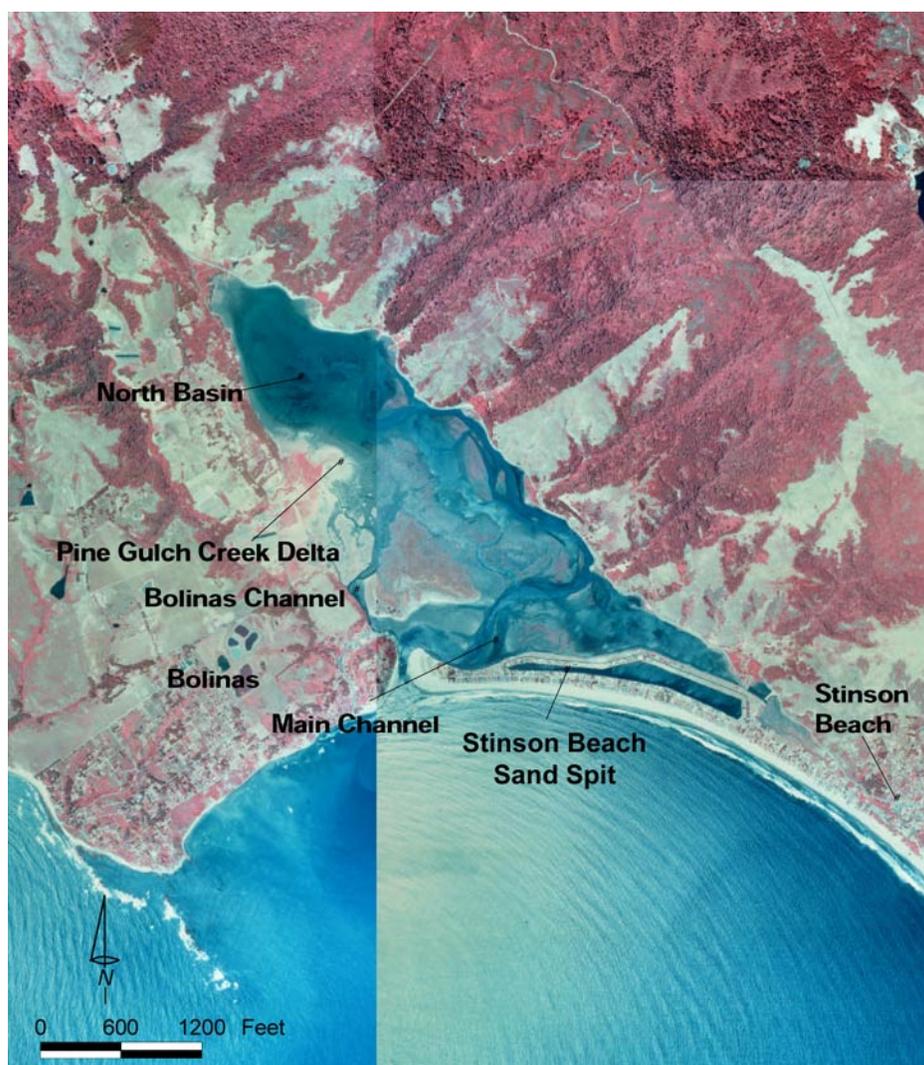
Figure 2-4. Current Configuration of Bolinás Lagoon

Note: Slight color differences seen on this figure are the result of splicing multiple aerial photographs.

Figure 2-3 shows the evolution of Bolinás Lagoon between 1854 and 1969, and Figure 2-4 shows the current configuration of the lagoon (Rowntree 1973). The lagoon morphology has been influenced by a number of geologic and hydrologic features; it is likely that the most important factors are: changes in sea level, uplift, and subsidence related to movement on the San Andreas Fault; erosion and sediment transport in the watershed; and wave and tidal action. Superimposed on these natural processes are human actions that influence the shape of the lagoon, including dredging and filling, and shoreline erosion protection. These processes occur at different rates, with different cycles of periodicity, and with different degrees of predictability. The ways in which these processes overlap determines the shape and depth of the lagoon. During the past 5,000 years sea level has been rising at an average rate of about one-half foot per century. Rising sea levels invaded the rift valley of the San Andreas Fault, forming a deep tidal inlet. As it did so, a sand spit formed in the shallow waters across the mouth of the inlet. The rift valley is a zone in which the land tends to subside due to movement along the San Andreas Fault. The subsidence occurs episodically. The 1906 earthquake,

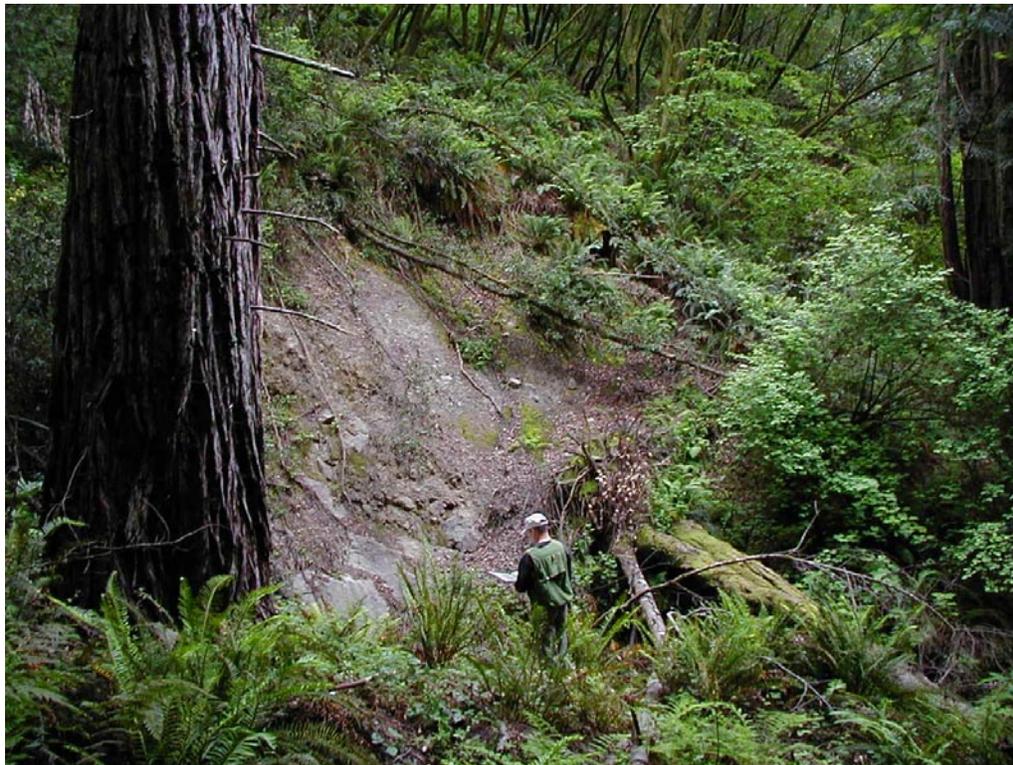
Figure 4-1. Streamside Landslide on Copper Mine Gulch

Of the 79 erosional features inventoried during the Bolinas Lagoon watershed stream surveys, 86 percent were shallow streamside landslides (Figure 4-1), 5 percent were rotational slides or slumps, 5 percent were earth flows (Figure 4-2), and 4 percent were gullies. A summary of the percent contribution of each mass wasting process is presented in Figure 4-3. Appendix A summarizes the landslide inventory data collected during field surveys. Streamside landslides, typically less than one meter in depth, generally occurred along confined channels and failed along shallow planar shear surfaces. Slumps (i.e., failures along rotational surfaces) were generally greater than 1.5 m in depth. Observed earthflows were large fluid-like mass movement of hillslopes and natural gullies were associated with either erosion at the base of earth flows or head cutting in low order channels.

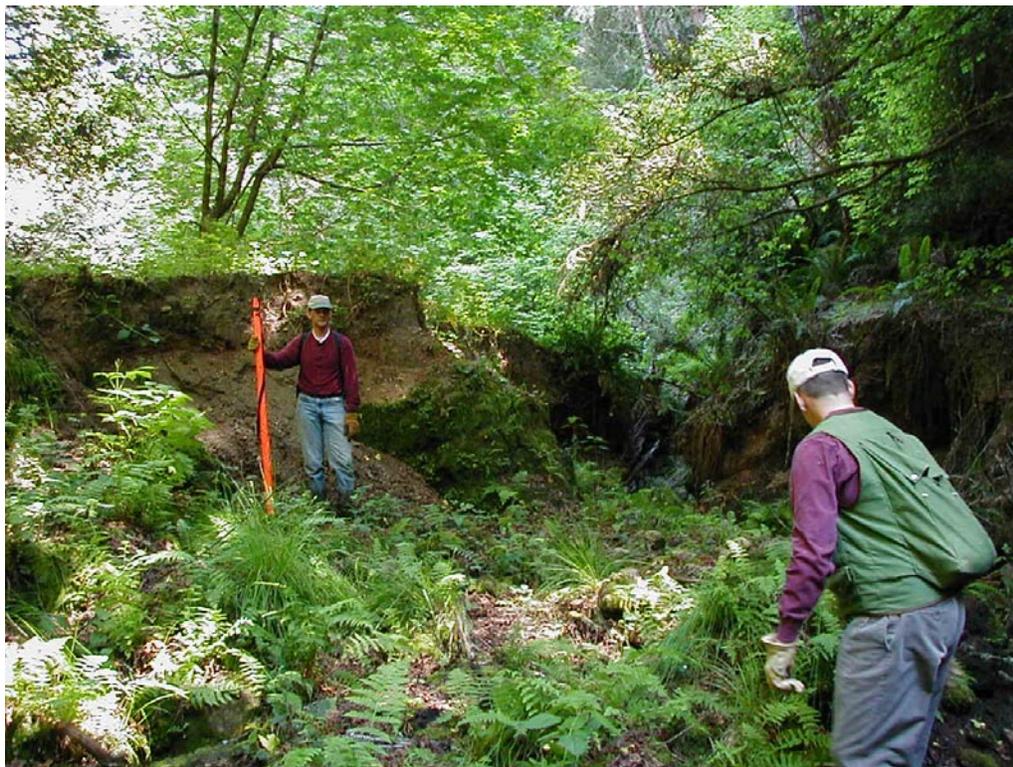
Figure 4-7. Field Measuring of Sediment Volume Accumulated in the Temporary Lake on McCormick Creek

The mass of sediment remaining in the reservoir (13,050 tons) was divided by 0.77 to account for a 77 percent trapping efficiency of small reservoirs (Dendy and Cooper 1984 as cited in Reid and Dunne 1996), and divided by the budget period (50 years, 1906-1956) and drainage area (1.8 sq km) to give an estimated sediment input rate of 189 tons/sq km/yr. Since the drainage area above the former landslide dam contains old growth Douglas fir and lacks indication of current or previous land management, the calculated rate most likely reflects natural processes only.

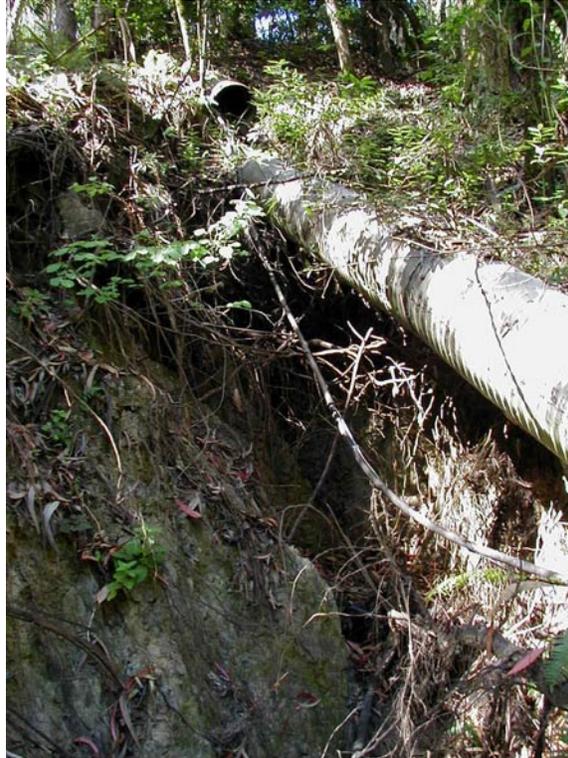
**Figure 4-8. Example of Gully From Paved Roads;
(Broken Culvert at Highway 1 South of Dogtown)**

For paved roads the two dominant processes observed were cutbank erosion and gullying at culvert outlets.

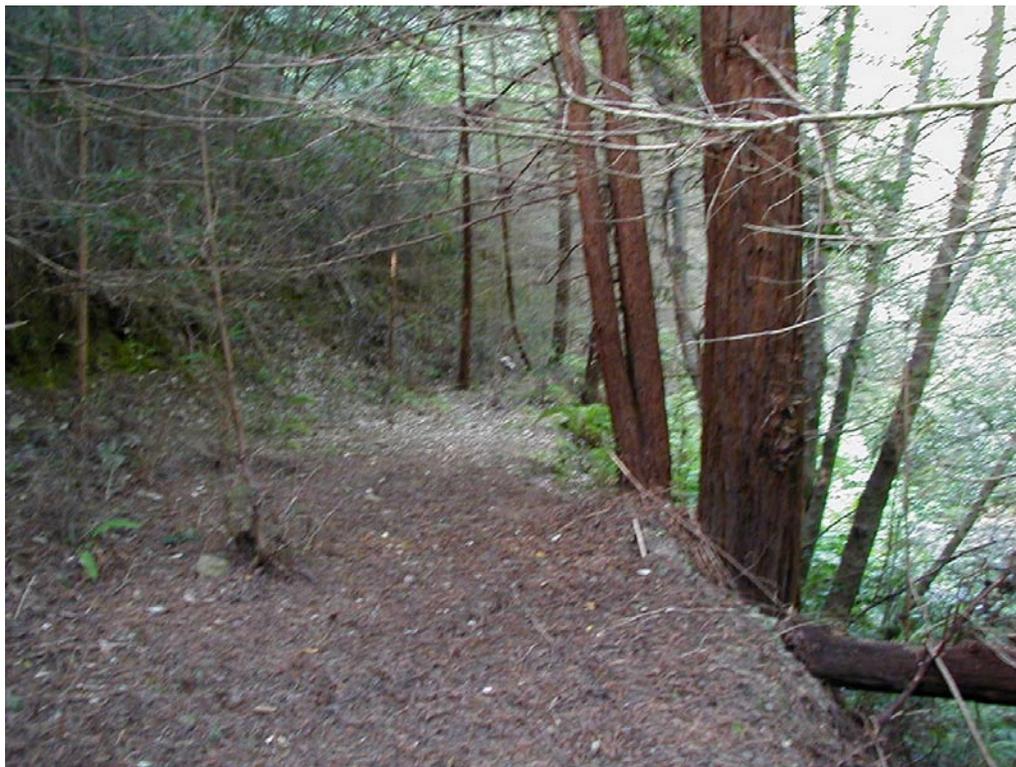
Figure 4-9. Abandoned Inner-Gorge Road at Righetti Ranch. (Note conifer trees growing on road prism and lack of visible surface erosion.)

Two logging operations are documented in the past fifty years of the watershed's history: Righetti Ranch and Sweet Ranch. Portions of both operations were surveyed and estimates of the road related erosion were made from each (Figure 4-9). The estimates were then extrapolated to the portions of the operations not surveyed. Righetti Ranch (90 acres, 0.36 sq km) yielded a road erosion rate of 340 tons/sq km/yr, or 2.8 tons/sq km/yr when prorated ($0.36 \text{ sq km} / 43 \text{ sq km} * 340 \text{ tons/sq km/yr}$) over the entire watershed. Sweet Ranch (400 acres, 1.7 sq km) yielded a road erosion rate of 48 tons/sq km/yr for the ranch area only, or 1.9 tons/sq km/yr when prorated ($1.7 \text{ sq km} / 43 \text{ sq km} * 48 \text{ tons/sq km/yr}$) over the entire watershed.

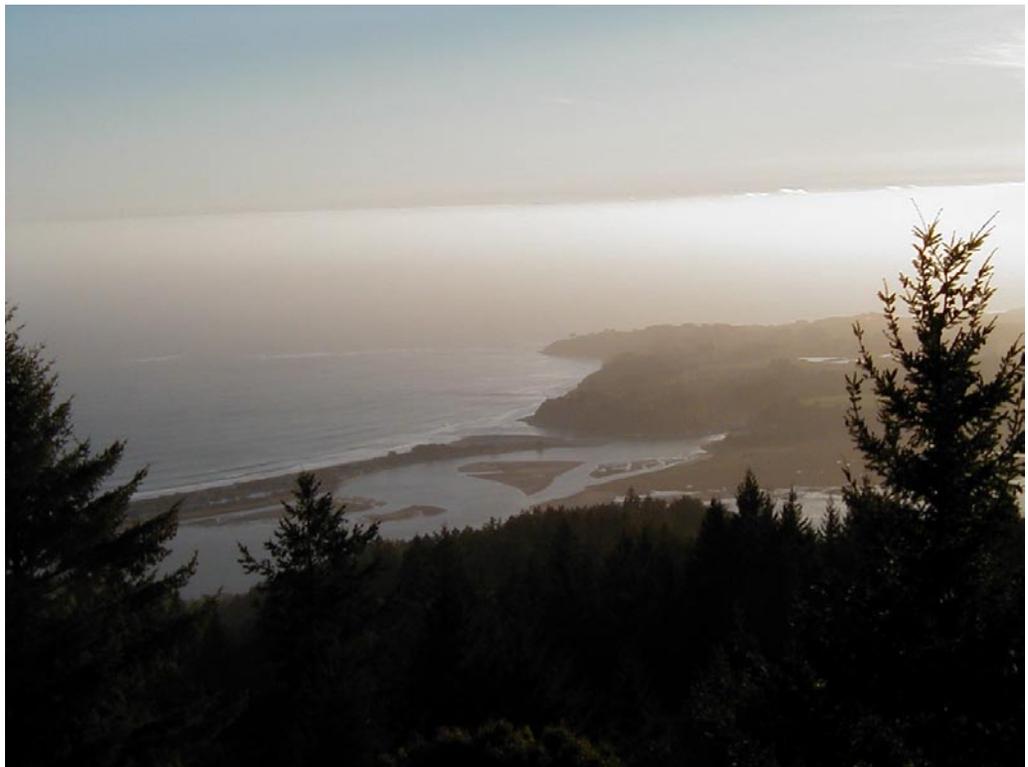
Figure 6-1. View of Bolinas Lagoon from the Ridge North of Mt. Tamalpias.

Photo 6-1 shows that this remains true today as shallow water and deposited sediment can be seen from neighboring Bolinas Ridge.
