Tomales Bay Eelgrass Habitat Evaluation, Site Monitoring and Restoration Plans

May 2018 Advisory Council Meeting

Site Monitoring in Areas Affected by Vessel Moorings

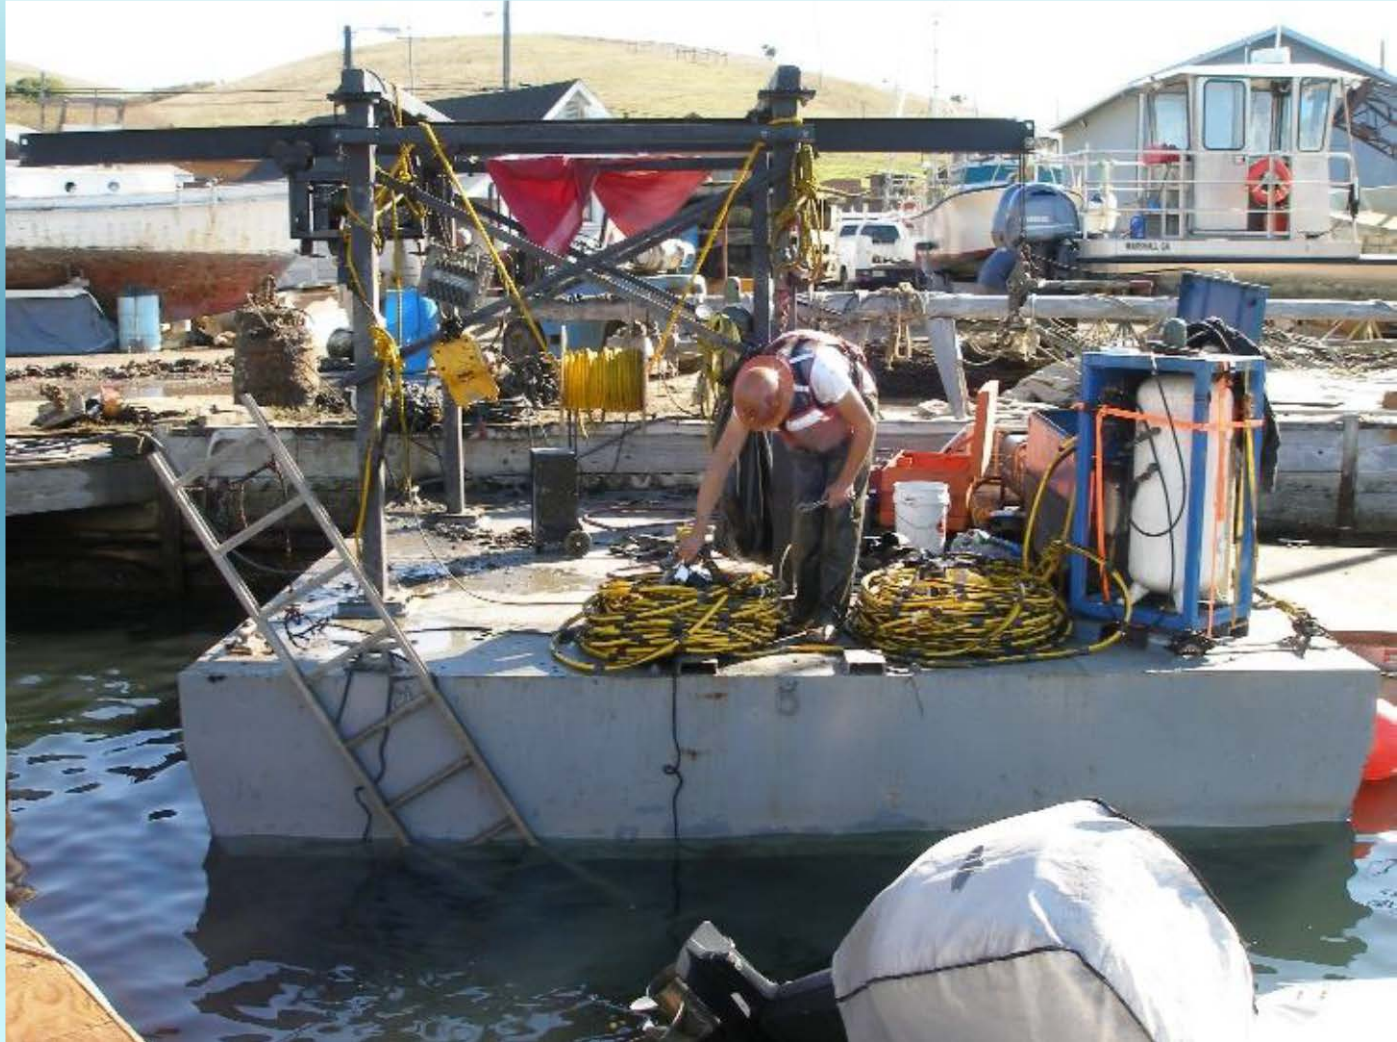
2016 Removal

1.20 FT10 38.14185, 122.87637
Cut chain on mooring.

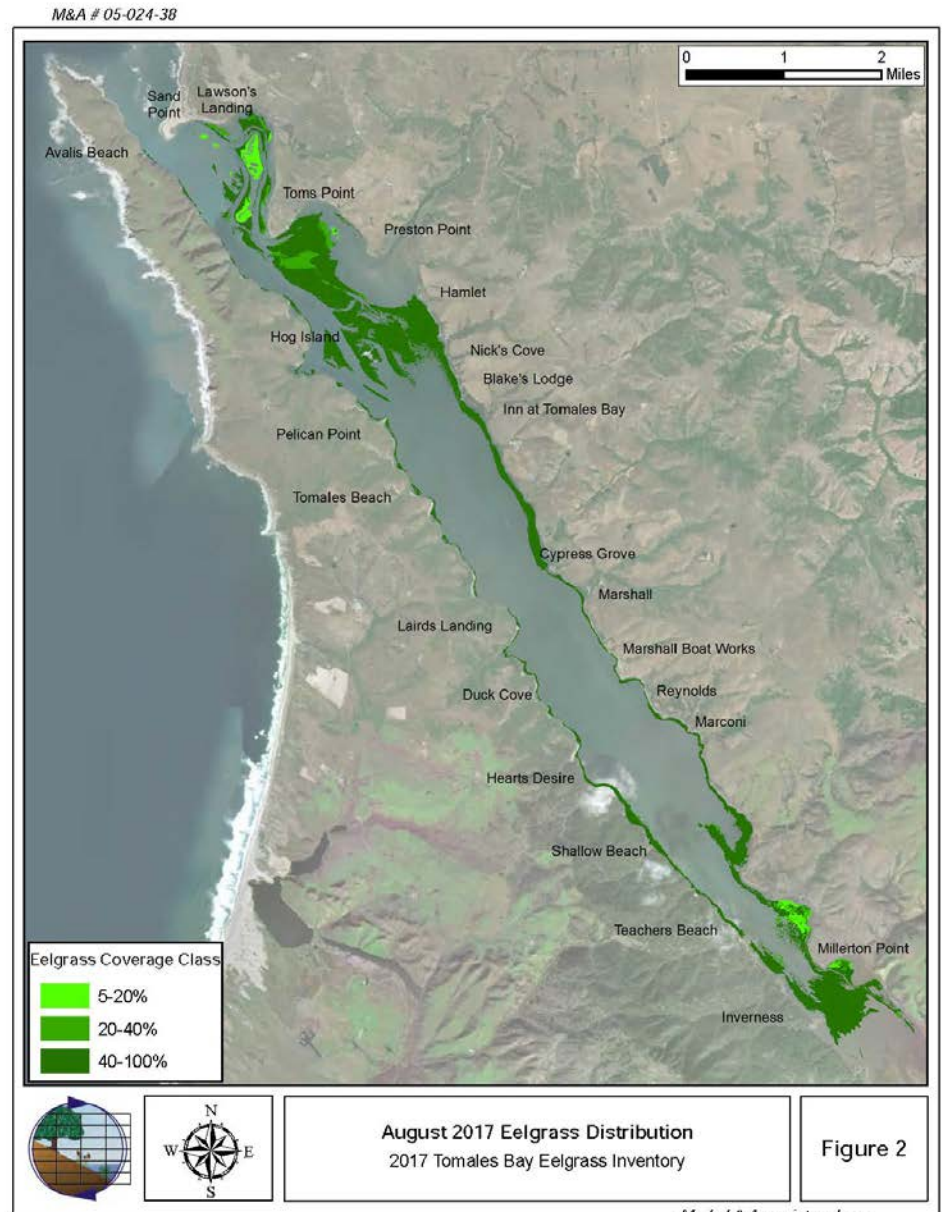
Our consultants mapped the full extent of eelgrass in order to understand the distribution below the elevations that could be detected using aerial photography.
